A Qualitative Infrared Thermographic Survey of Electrical System Components

Report Date	January 26, 2015	Report # /Time	2 of 15 @ 1:09 PM
Company	Windemuller Technical Services (941) 355-8822	Customer	Tradeshow Sample
Address	1611 Northgate Blvd. Sarasota , Florida 34234	Site Address	Sarasota, Florida
Thermographer	David Lemieux Certified Level I Thermographer	Contact Person	
Location	Third Floor Storage	Equipment	AHU 2-9 VFD

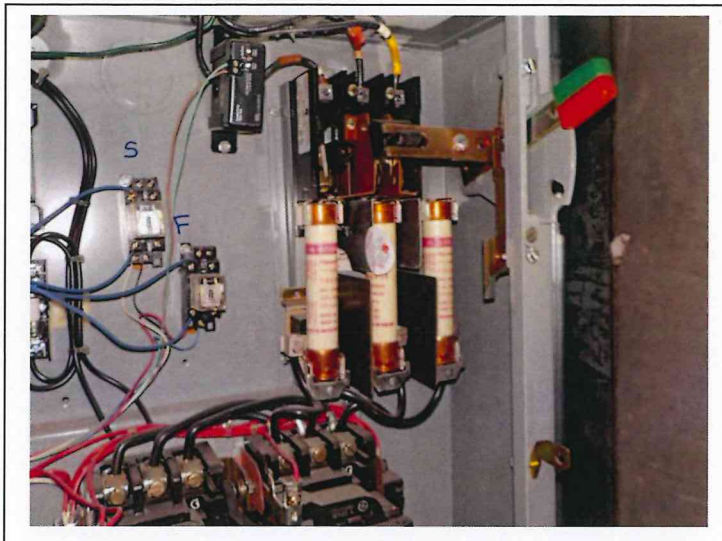
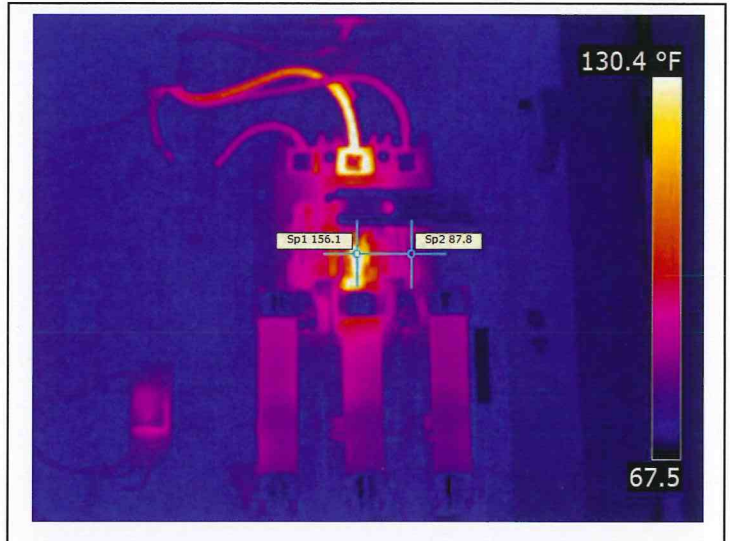
Camera Model	FLIR ThermaCAM EX320	Hot spot temperature	156.1 Degrees F.
Image Date	1/26/15	Cold spot temperature	87.8 Degrees F.
Image Name	IR_295.jpg	Delta T (difference)	68.3 Degrees F.
Image Time	1:05 PM	Ambient Temperature	70.0 Degrees F.
Emissivity	0.98	Relative Humidity	65%
Object Distance (approx.)	3.0 Ft.	Fault Rating	3

Raised temperature noted on in-feed B phase side of fuse carrier. Temperature imbalance such as this would not be expected across a fuse and indicates an internal problem. Possible source of temperature rise includes poor connection, loose fuse fixing, or high resistance blade connections.

De-energize, repair, and re-inspect.
 Recommendation is to inspect, check fuse carrier blades for signs of pitting or heat damage, re-tighten the fuse fixings and re-tighten all connections.
