Infrared Scan Inspection Report

Report Date	August 22, 2014	Report number	#1 of 1
Company	Windemuller Technical Services (941) 355-8822	Customer	Tradeshow Sample
Address	1611 Northgate Blvd. Sarasota , Florida 34234	Site Address	Sarasota, Florida
Thermographer	David Lemieux Certified Level I Thermographer	Contact Person	
Location	Heat treat area	Equipment	Panel "PP"

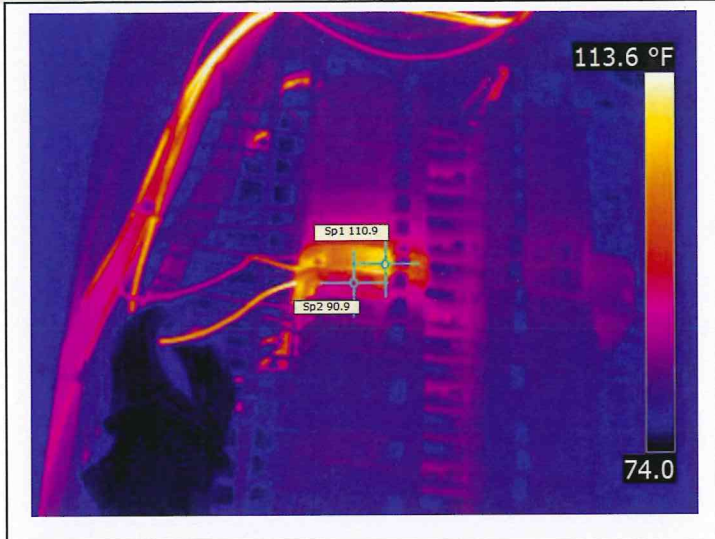
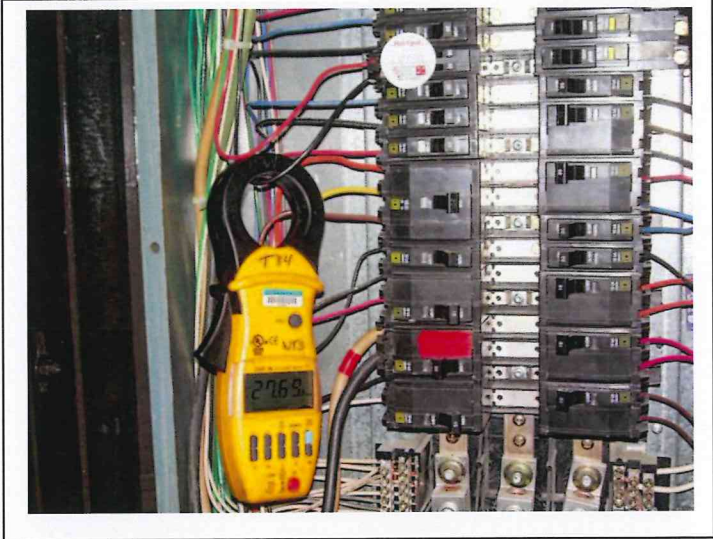
Camera Model	FLIR ThermaCAM EX320	Hot spot temperature	110.9 Degrees F.
Image Date	August 22, 2014	Cold spot temperature	90.9 Degrees F.
Image Name	IR_242.jpg	Delta T (difference)	20.0 Degrees F.
Emissivity	0.98	Ambient Temperature	76.0 Degrees F.
Object Distance (approx.)	3.3 Ft.	Relative Humidity	64%

1. Repair Next Maintenance	2. Repair as Schedule Permits	3. Repair Immediately	XX
----------------------------	-------------------------------	-----------------------	----

Temperature increase on a space #15 tandem 30Amp breaker. #15a measures 14.0amps and #15b measures 27.7amps. No information was available at the time of survey to indicate the downstream device but high amprobe readings indicate an issue worth investigating.

Recommendation is to inspect and identify downstream connected device(s). Check expected operating currents and divide Breaker #15b circuit if necessary to reduce load.
